Appendix E2. b – Restoration Plans and TMDLs (Restoration Plans)

Subject: Swan Creek Restoration Plan for Sediment

To: Harford County Watershed Protection and Restoration Office
From: Maryland Department of the Environment (MDE) – Integrated Water Planning Program (IWPP)
Subject: Conditional Approval of Harford County's Stormwater Wasteload Allocation (SW-WLA) Watershed Implementation Plan (WIP) for the Total Suspended Solids (TSS) impairment of Bynum Run

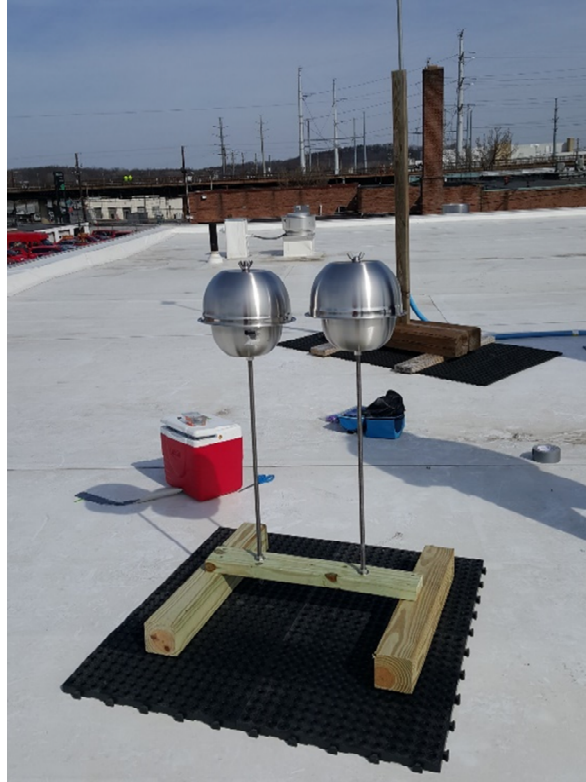
Figure 3: Passive air samplers deployed on the rooftop at the River Terrace location. The passive sampling polymer medium is enclosed within the bowl-shaped enclosure to protect the polymer from direct deposition and influence of solar radiation. Passive air samplers deployed on the rooftop at the River Terrace location.
